CONSIDERATIONS ON OVERALL STABILITY OF GAP CREATED, IN 22 DECEMBER 2010, IN TOWN OCNA MUREȘ, COUNTY ALBA

Raluca Farcaș, *Ph.D-student, University of Petrosani*
Nicolae Dima, *Prof.Ph.D., University of Petrosani*

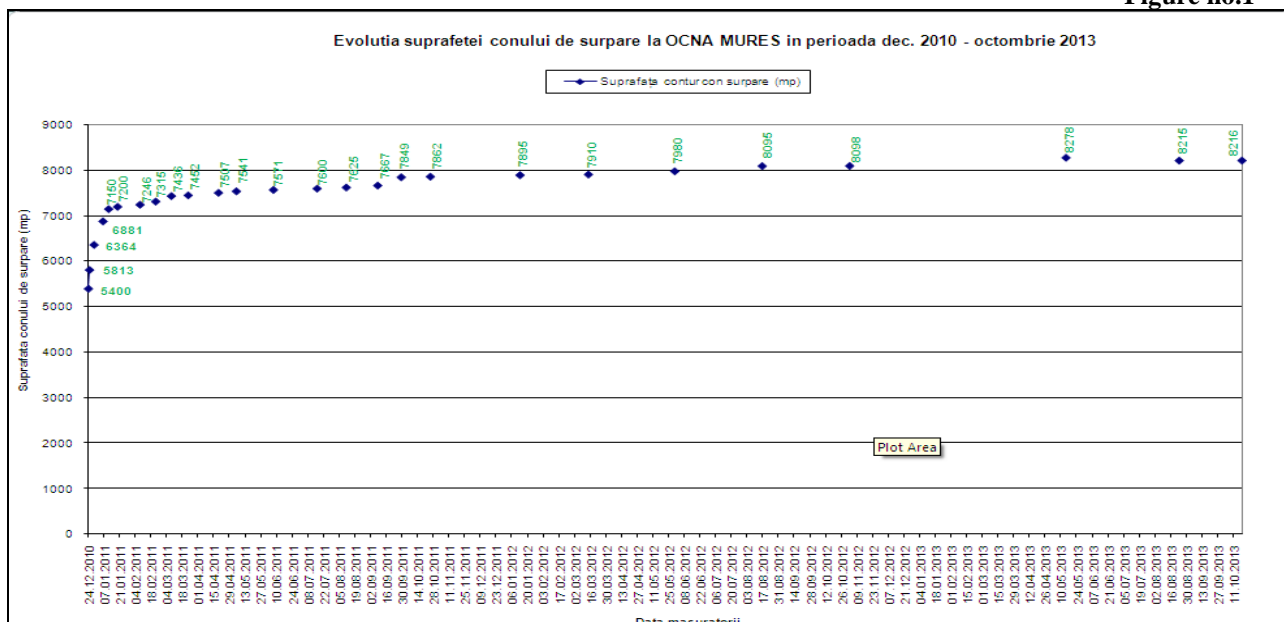
Figure no.1

Evolution surface contour of the cone crumbling, monitoring in the period December 2010 - October 2013 is presented in figure no.1

The increase surface contour of cone crumbling in 18.10.2013 compare to 23.12.2010 is 52.14%.

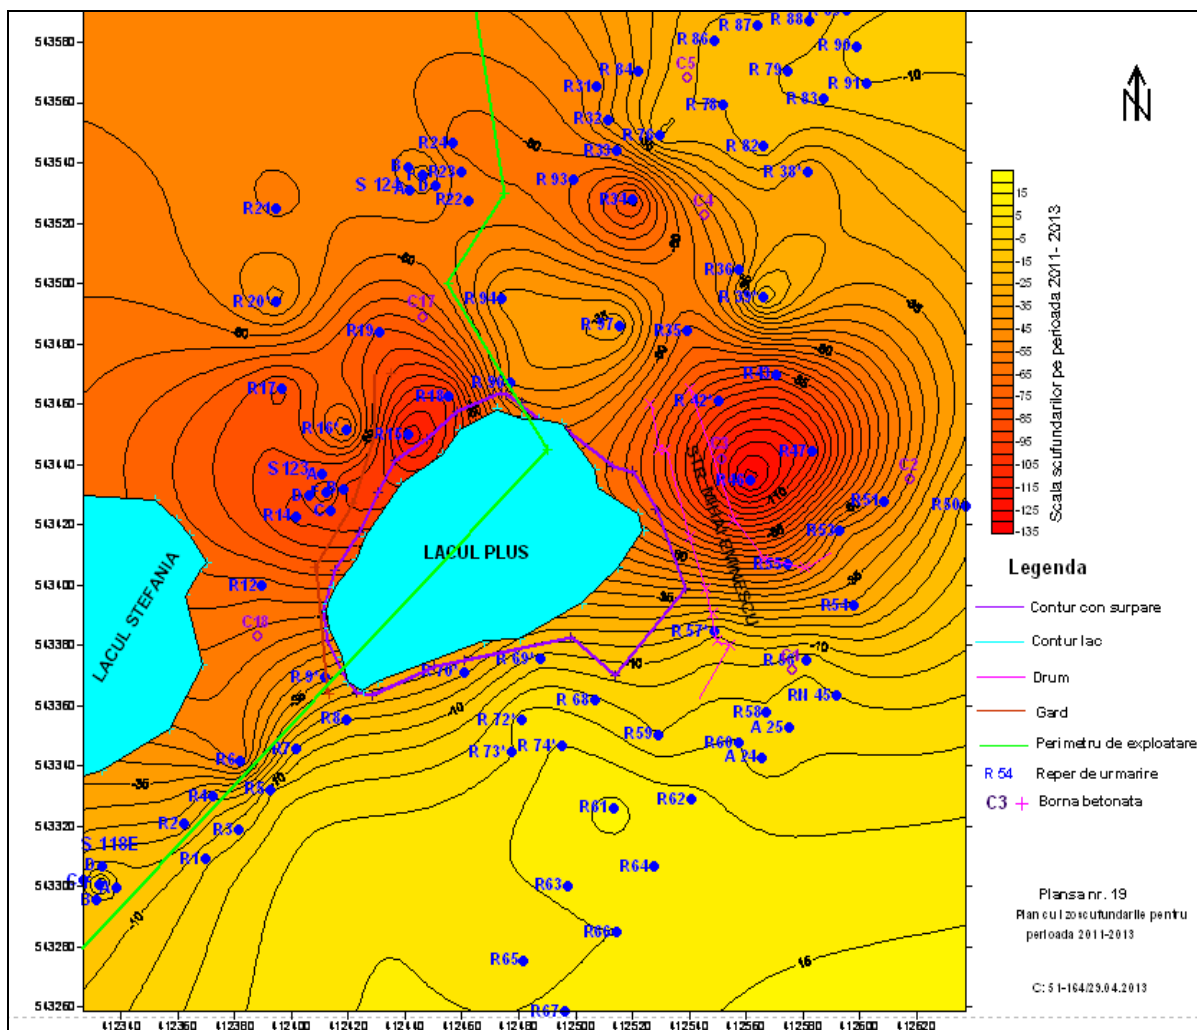
Figure no.2 –“Izoscufundări: Ianuarie 2011 ÷ Octombrie 2013, Ocna Mures” (C: 51-164/2013)

To get a clearer picture of areas where there is the maximum vertical displacements recorded for the period January 2011-October 2013 was represented Fig. 2 "Izoscufundări -January 2011 ÷ October 2013, Ocna Mures".

It notes that the ground highlights R46 -R47 were recorded the highest values of vertical displacements ranging from [-110.3 ÷ 134.2 mm].

Diving iso curves reflect well the reality only near the landmarks for which are known coordinates and total diving for the 2011-2013.

Diving iso curves drawn measurements based on the processing results for the period 2012 - 2013 (for the spotted wells placed at feet and flanges) configures areas where landmarks have been positive or negative vertical displacements.
