# Biolog Vesa (Benea) Mărioara

# (SUMMARY OF PhD THESIS)

# CONTRIBUTIONS REGARDING POLLUTION AND DEPOLLUTION IN THE PERIMETER OF CERTEJE, HUNEDOARA COUNTY

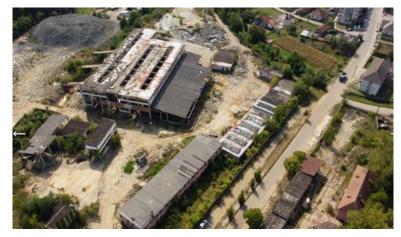
Figure 6.5. Top view of the Certej area (<u>https://adevarul.ro/stiri-locale/hunedoara/certej-blestemul-aurului-din-muntii-metaliferi-</u>)

Wooded hills add context to the landscape, highlighting the contrast between natural areas and those affected by industrial activities. Dense vegetation on the hills suggests a healthy ecosystem, while the eroded area indicates soil destruction and loss of ecological stability.

The visual impact of tailing pond degradation is accentuated by contrasting colors and textures: the vibrant green of healthy vegetation and the grey-brown of exposed and eroded soil. This image reflects the negative effects of industrial exploitation on the environment and the need for remedial measures and protection of natural ecosystems.
