# RESEARCH ON LOAD CARRYING CAPACITY OF BASE TERRAINS OF THE WASTE DUMPS IN JIU VALLEY

Maria LAZĂR\*, Adrian FLOREA\*\*, Florin FAUR\*\*\*

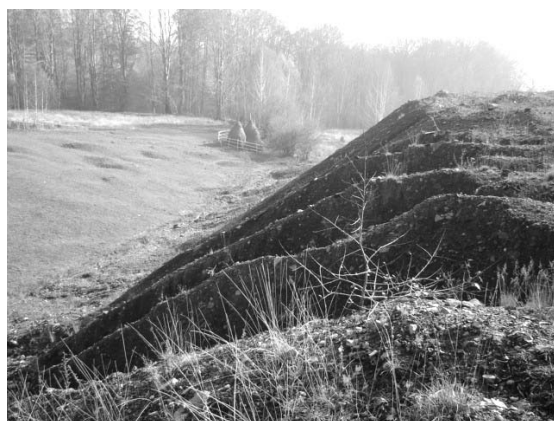
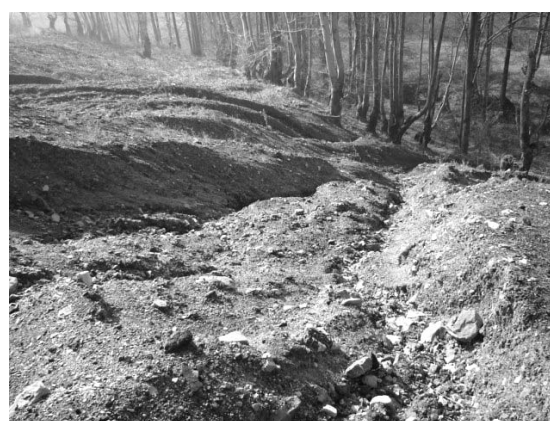
**Fig. 2** Erosion phenomena on the northeastern (a) and southwestern (b) slope of the dump

Erosion occurred as a result of mechanical action of surface water from rainfall and the lack of catchment and routing works, which led to the formation of gullies of different sizes, depending on the intensity of the runoff and the degree of compaction of the dumped material (fig. 2).

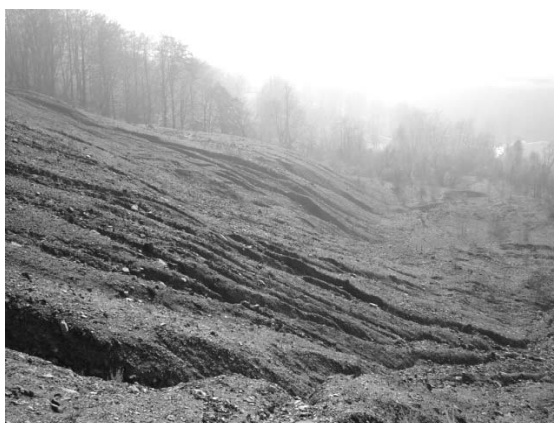
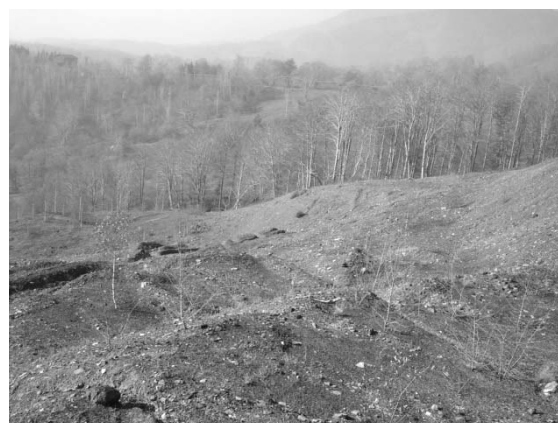
**Fig. 3** Discharge of rocks through the base land in the slipping area

Discharge of rocks occurred in the base land, at the boundary of the slope sliding area in the southwest part of the dump (fig. 3), and they occurred due to transmission of the slipping through the direct foundation (topsoil) by pushing rocks from the bottom of the dump [5].

Works for combating negative geomining phenomena were minimal, summarizing to the leveling and terracing works executed to restore the dynamic balance of active and passive forces in the area affected by the landslide.

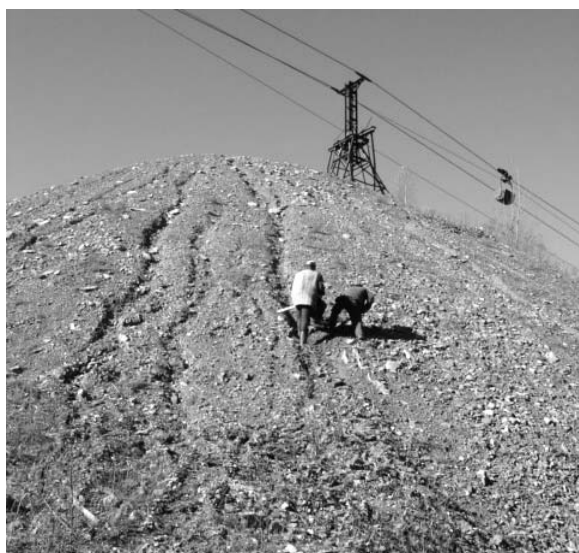
**Fig. 4 Erosion phenomena**

Erosion occur as a result of training the dumped material by runoffs, the dump being affected by such events on the side slopes (fig. 4).

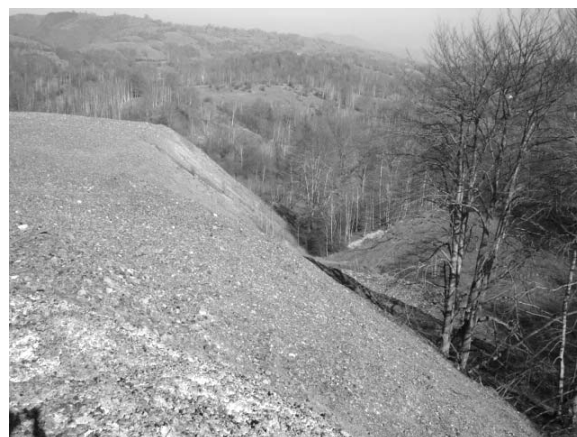
**Fig. 5 Eastern and western slopes**

In terms of geometry, the waste dump is characterized by high values of the height and slope angle (often exceeding 30 m height and the slope angles are between 30 - 43° (fig. 5). Due to geometric elements, land's morphology and by worsening the physical and mechanical characteristics of the deposited rock and the rocks from the direct foundation (represented topsoil), rainfall and the existence of lakes from which water seeps under the dump, the eastern slope was affected for a number of slides that have expanded and covered the road in the area (fig. 6) [5].

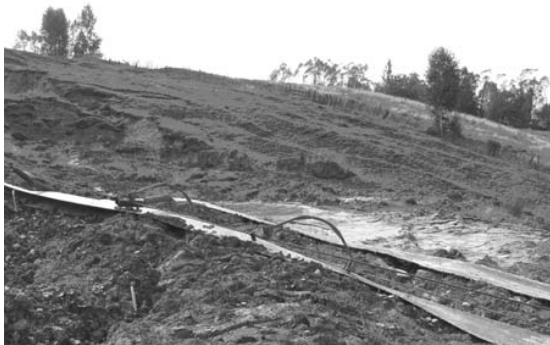
**Fig. 7** Discharge phenomena and slope ruptures

The old dump of Lonea mine is affected by phenomena of ruptures, curls, thrusts and plastic slides of the slope and plastic failure phenomena of the base land, particularly in the north-east (fig. 7) [5]. At the base of the new dump there were

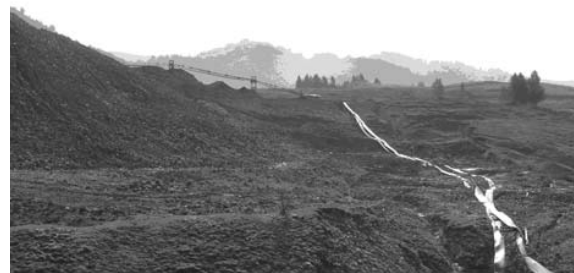
**Fig. 8** Ruptures, slides, discharges and gullies

identified a number of water reservoirs, which are located along the abandoned conveyor route on a NW-SE direction, over a distance of 30-50 m (fig. 8). The status of tensions in the area is explained by the absence of an appropriate geometry, improper geometrical parameters of slopes (19-20 m height and inclination of 30°-50°) and the presence of water seepage at the contact between the dump and the base land.
