## IMPACT OF AN ABANDONED MINING SITE - CENTRAL FLOTATION PLATFORM

DOI: 10.2478/minrv-2021-0005

## 2. Description of the impact and current status of the platform

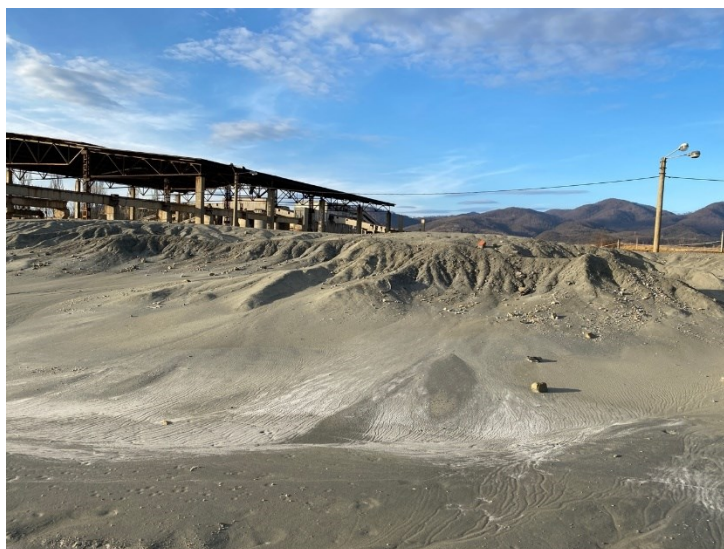
Within the Central Flotation, the complex ores from the Baia Mare region were processed with polymetallic sulfide contents and with large quantities of pyrite and marcasite, which represent the triggering mineralization of the acid drainage. The quantities of ore and concentrate in climatic conditions specific to the area (temperate climate with precipitation, followed by hot periods, dry with winds) allow the ideal conditions for oxidation of sulfides with sulfate formation, which become soluble and easy to transport through the environment. Through careful monitoring, especially in the last 10 years, this cycle of sulphate formation and their entrainment during periods of precipitation was systematically noticed. Oxygen-laden precipitation water (free oxygen) contributes to the formation of new sulfates, which in turn will be entrained in the next precipitation. These phenomena are visible and captured in the following photos.

*Figure 1 Presence of sulphates formed on the concentrates remaining in the mining perimeter (in dry periods that disappear during precipitation)*

A perimeter like the one presented must be rehabilitated and be made ecologically friendly as soon as possible, in order to stop the negative effects on the local area and on the health of the population

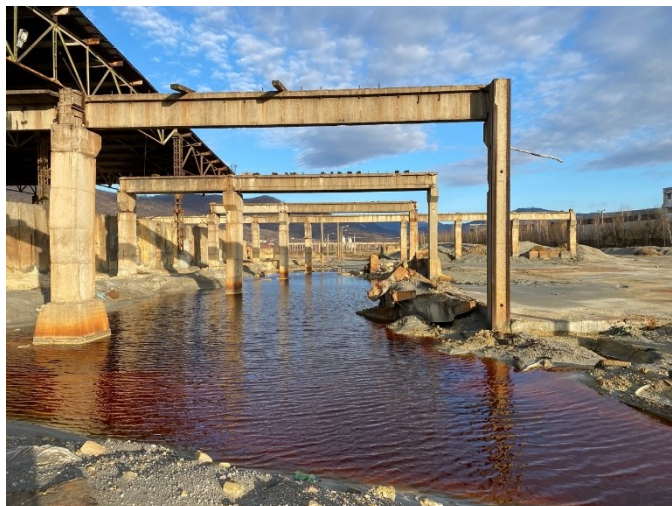
Compounding this situation is the added supply of mine water from the Herja mining perimeter through the Herja tunnel - Central Flotation. Since the last period of activity of the Herja mine, this tunnel was completed and used to transport the ore on the belt from the mine's underground directly to the Central Flotation. Another uninspired decision was to design the closure of the tunnel at the flotation exit by building two dams and backfilling the space between them, in order to accumulate water in the underground of the mine and the subsequent discharge through the base gallery inside the Herja mine, where there is a wastewater treatment plant. The difference in level between the exit of the tunnel and the base gallery is 220 m. Under these conditions, two major risks could have been anticipated, described and published in a scientific paper immediately after the execution of the closure works [3]. These inevitable risks were given by the chemistry of the mine waters and their interaction with the concrete used at closure and the difference in level by the accumulation of mine water in the underground of a cracked, fragmented, faulty structure, both naturally through geological structure and mining. drilling - shooting, excavation, on large horizontal and vertical surfaces, through which inevitably the mine waters generated leaks and were unlikely to reach the level of the base gallery. Shortly after the closure of the works (5 years), the mine water percolated the wall inside the Central Flotation with significant mine water leaks. Personal monitoring of the perimeter allowed the identification of these evacuations in 2017. The mine waters reach the premises of the Central Flotation, adding to those existing in the perimeter of the flotation.

*Figure 2 Mine waters in the perimeter of the Central Flotation*

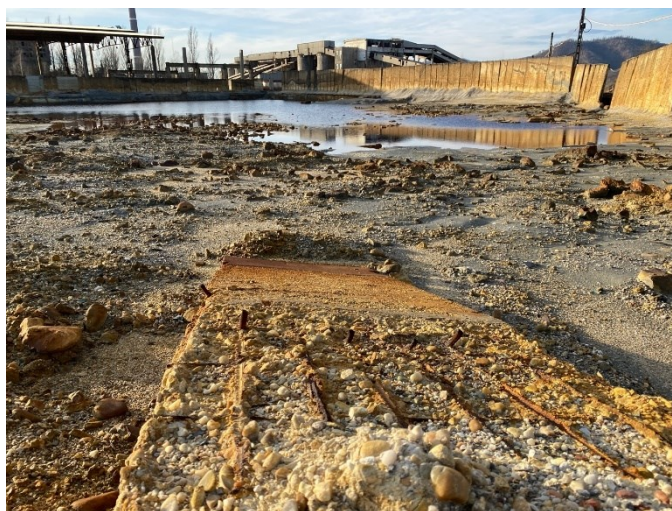
These waters have a strong acid character and are loaded with heavy metals. They flow directly into the Sasar River and seep into the groundwater. The platform was partially paved with concrete, but there are sections with concrete discontinuities through which pollutant leaks take place. The geological structure consists of the terrace of the Sasar River, a permeable structure. The latter creates the conditions for the infiltration of toxic waters into the aquifers.

*Figure 3 Framing the site in the natural landscape of Baia Mare and the presence of acidic waters and the impact on concrete*
