## **ALIGNMENT OF VIBRATION EFFICIENCY ON AXIAL FAN FUNCTIONING. CASE STUDY.**

**Key words:** mechanical vibration, axial fan for mining, alignment, signal processing.

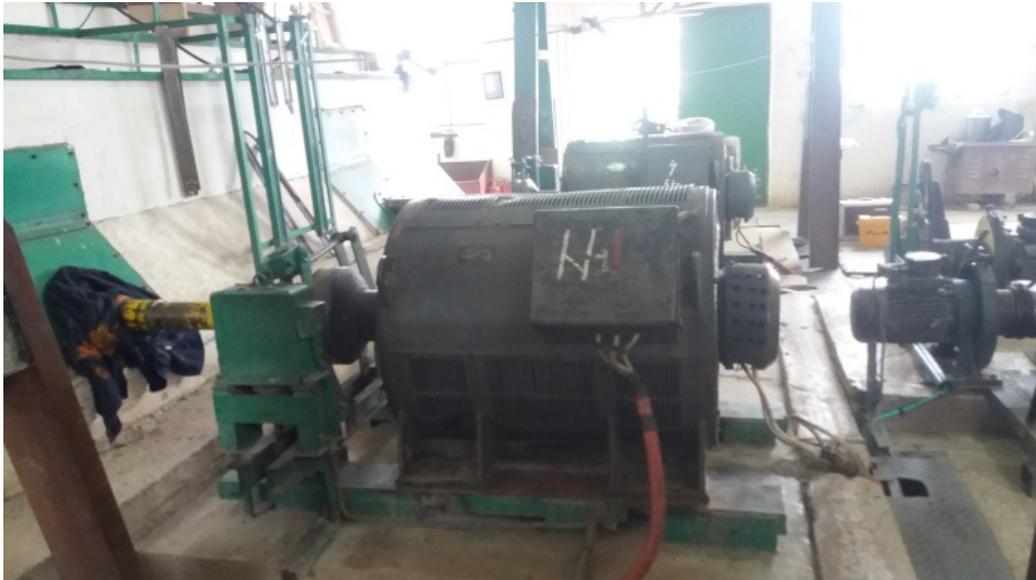
All tests were performed on two Russian-made VOD 2.1 axial fans (figure 1), from the Vulcan Mining Plant.

**Fig. 1.** The VOD 2.1 axial fans at EM Vulcan

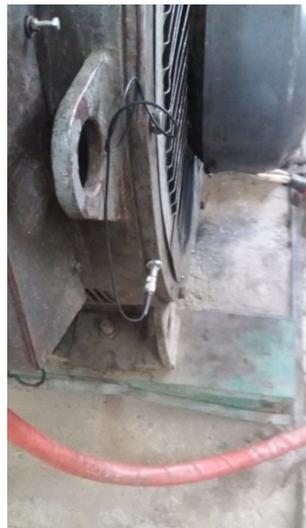
The vibrations were measured with piezoelectric accelerometers placed in specific locations as presented in figures 2 (schema) and 3 (photo on actual location).

**Fig. 3.** The actual placement of the piezo accelerometer in situ
